ANDOVER RIVER BASIN
WEARE, NEW HAMPSHIRE

**WEARE RESERVOIR DAM
NH 00114**

**PHASE I INSPECTION REPORT
NATIONAL DAM INSPECTION PROGRAM**

AUGUST 1978

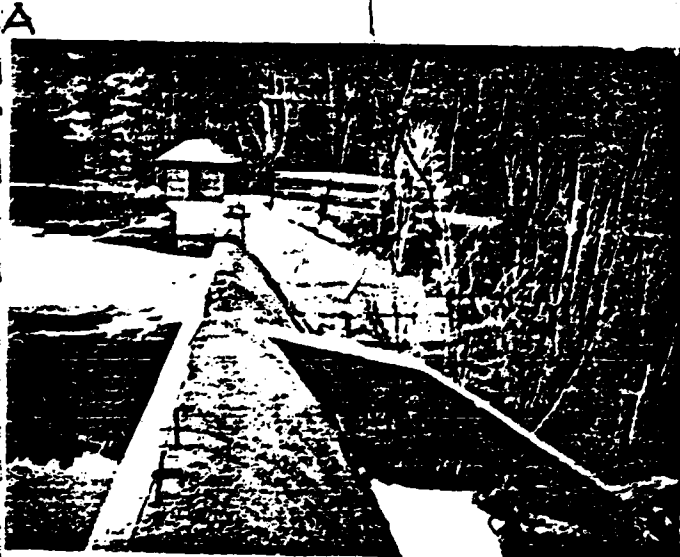
CRACKS

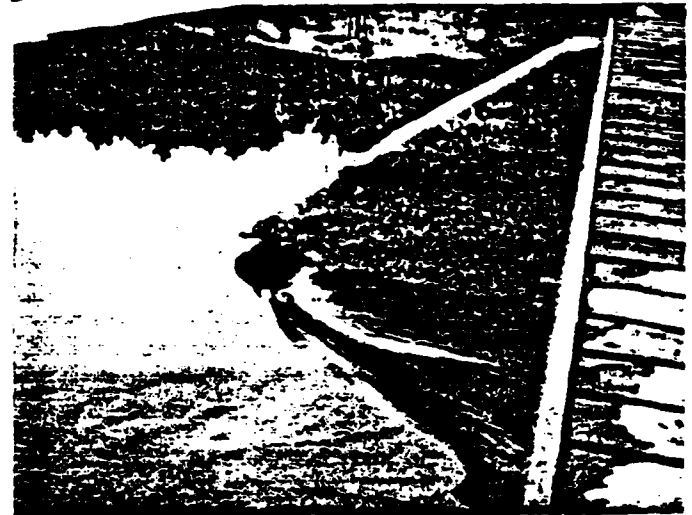
WATER FLOWING UNDER
CONCRETE

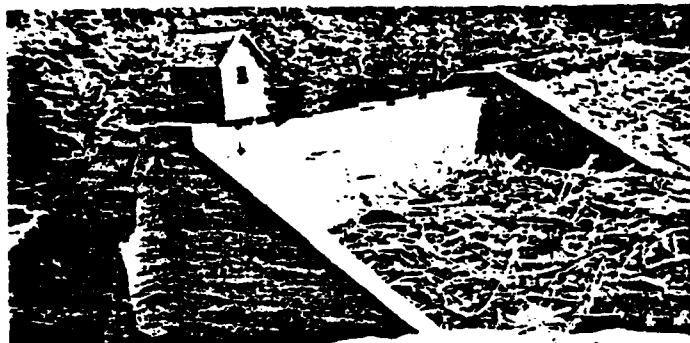
LEFT ABUTMENT WASHED
OUT IN 1938 FLOOD
